# Outline of Water Injection to Reactors by Fire Engines

Fukushima Nuclear Accident Analysis Report (Interim Report)  
which was released on Dec. 2, 2011

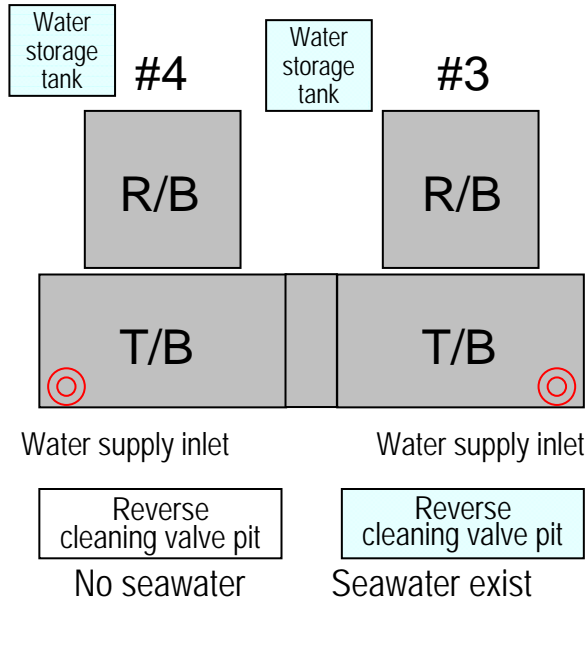
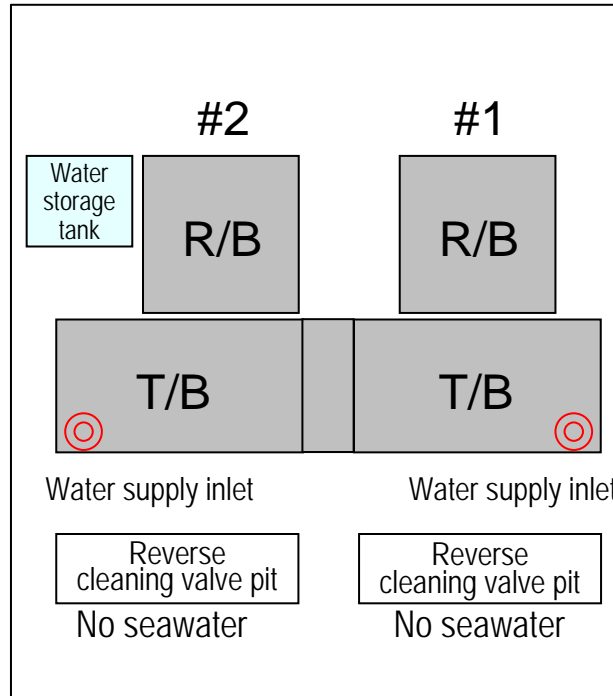
(1) Status after Tsunami  
(Mar 11 around 15:40)

Impassable due to road damage and debris carried by tsunami

Impassable because the tanks carried by tsunami blocked the way

Breakdown due to tsunami

- Status of 3 fire engines deployed at the power plant:
  - One fire engine deployed in the fire engine house on a hill was usable.
  - One fire engine deployed near the safeguard headquarters on the Units 1-4 side was broken down due to tsunami.
  - One fire engine deployed on the Units 5/6 side was not usable because the passage to the Units 5/6 side was interrupted due to road damage and debris carried by tsunami, and there was information that the fire engine was swept up by tsunami.

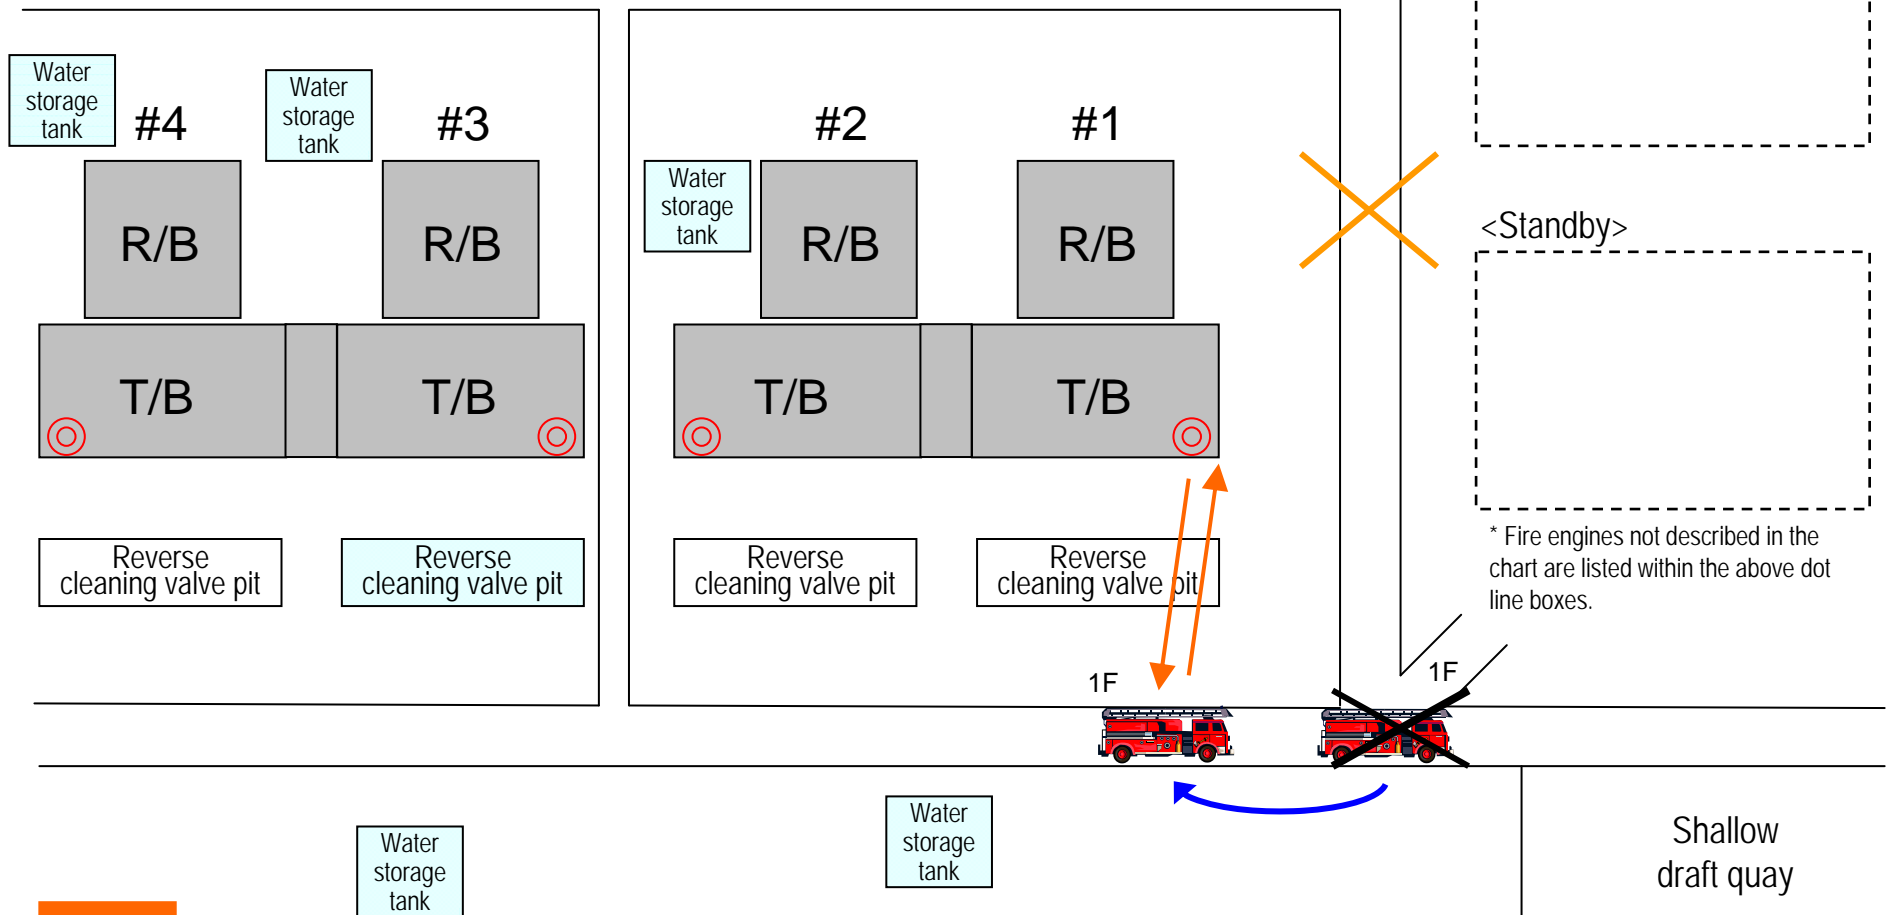
(2) Start of freshwater injection to Unit 1  
(Mar 12 around 4:00)

- Around 3:30 TEPCO employees and partner companies went to the site and found the Unit 1 power supply inlet. Around 4:00 the water (about 1300L) stored in the fire engine was injected.
- During the attempt to use the water stored in the broken down fire engine, around 4:20 the staff returned to the seismic isolated building by fire engine due to increased radiation dose.

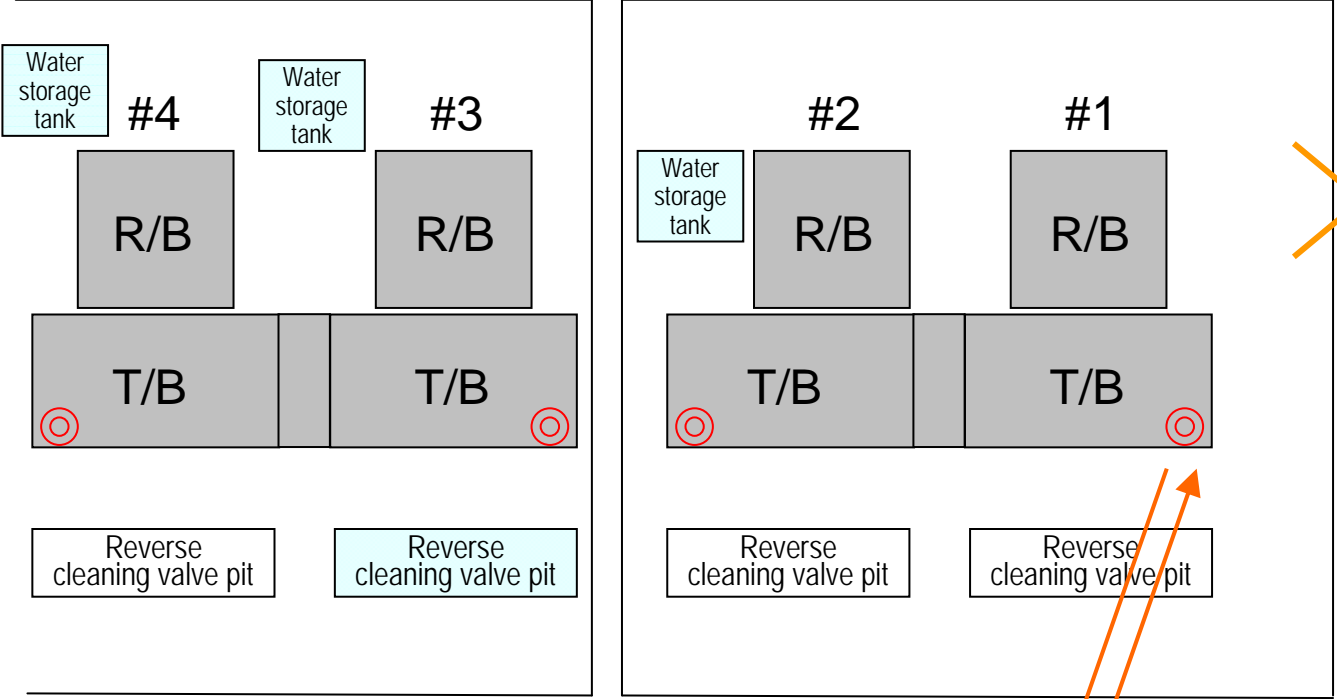
(3) Restart of freshwater injection to Unit 1  
(Mar 12 around 5:46)

- Self-Defense Forces and partner companies went to the site by fire engine and restarted the water injection at 5:46.

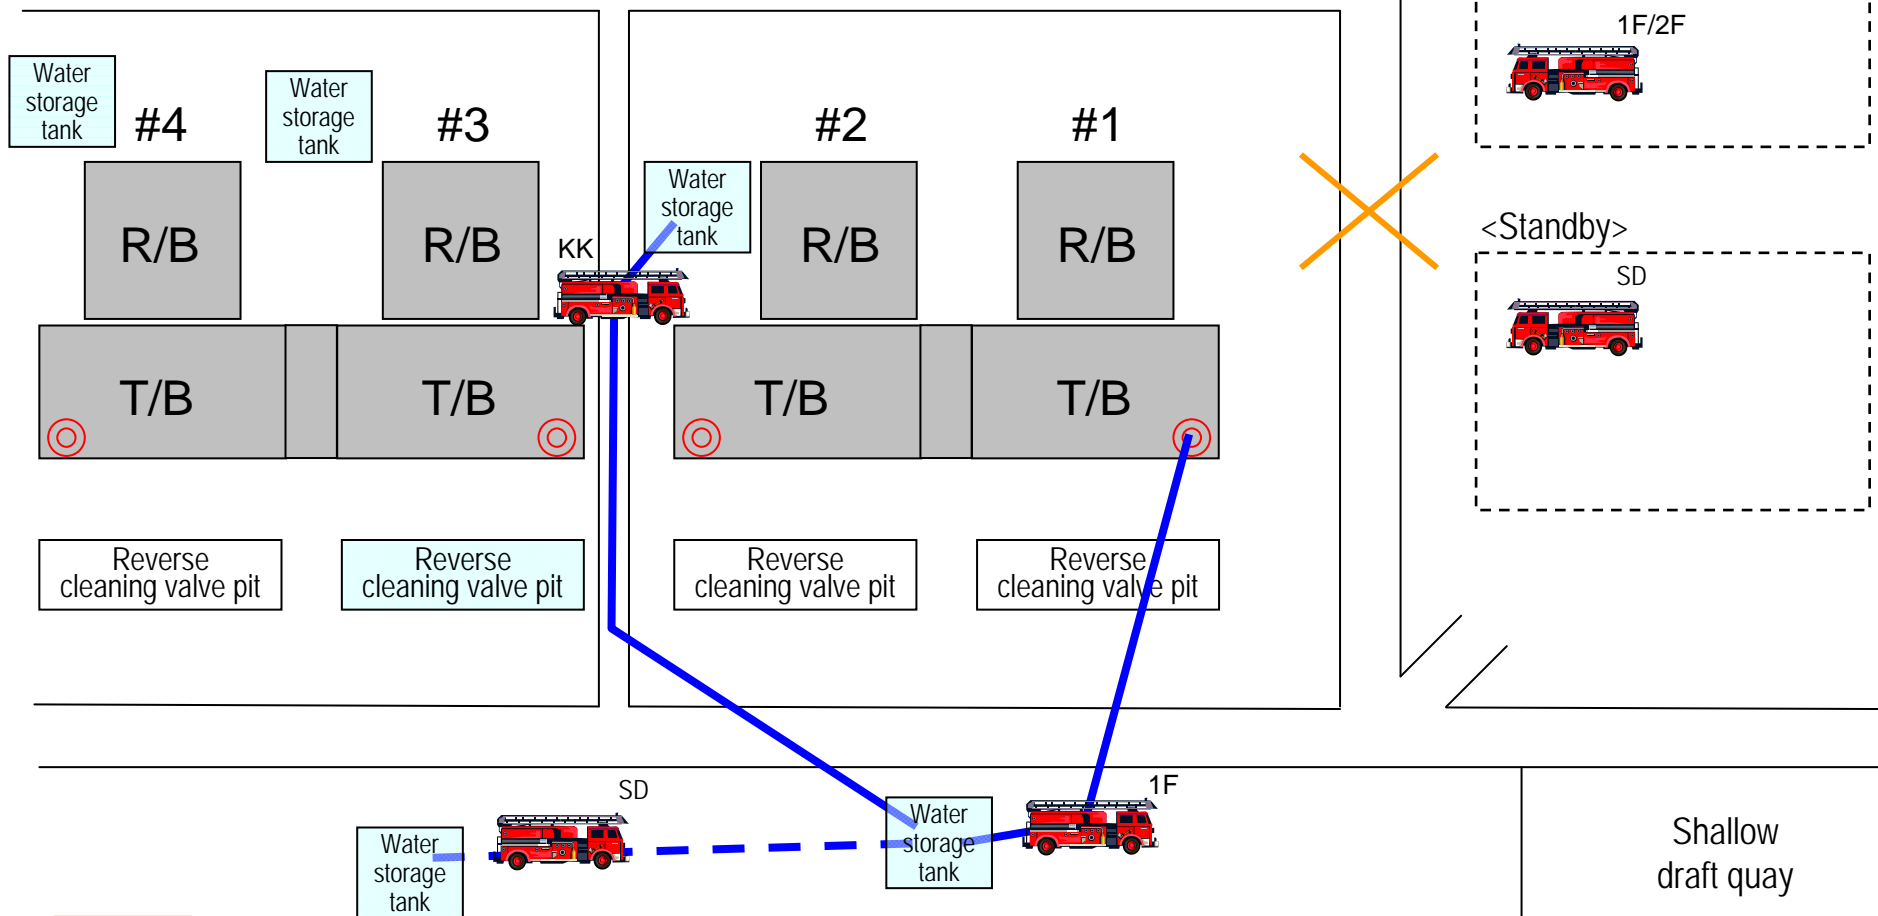
(4) Start of continuous injection, and arrival of support fire engines  
(Mar 12 in the morning)

- Continuous water injection line from the water storage tank to water supply inlet was installed to inject water.
- KK arrived at the site around 10:30, and the fire engine of Self-Defense Forces arrived before noon. Water was supplied from water storage tanks around the site to the water storage tanks to the Unit 1 side.
- In addition, 1 chemical fire engine shared by 1F and 2F was moved from 2F. (The fire engine was not used actually because of its old model.)

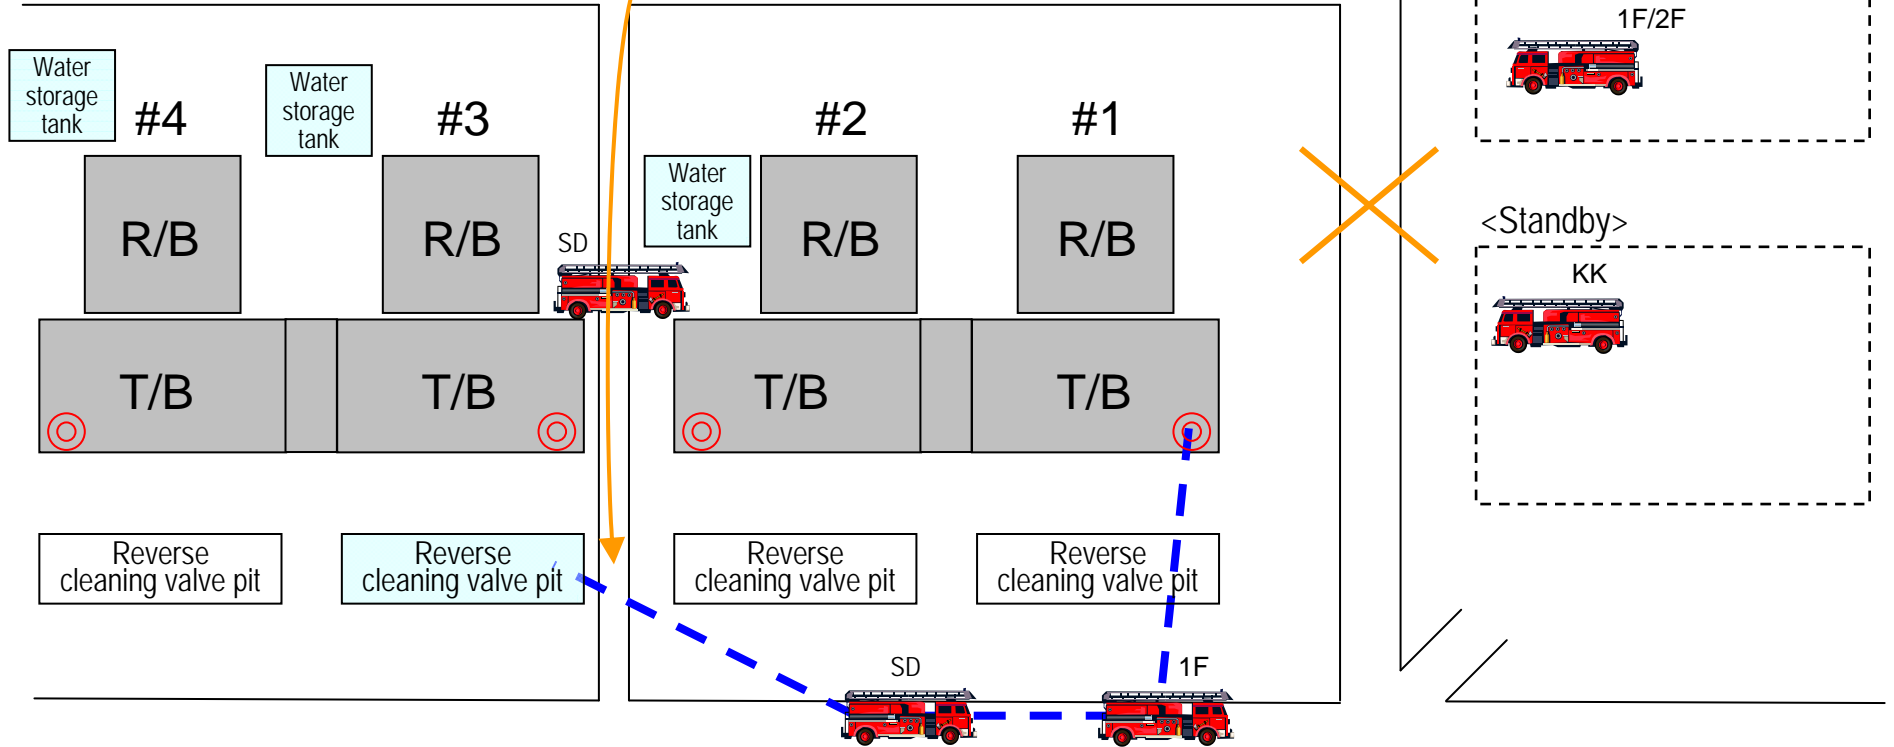
(5) Hydrogen explosion at Unit 1  
(Mar 12 15:36)

- After the explosion, all workers evacuated to the seismic isolated building.
- The hose prepared for seawater injection was damaged and not usable due to the impact of explosion.

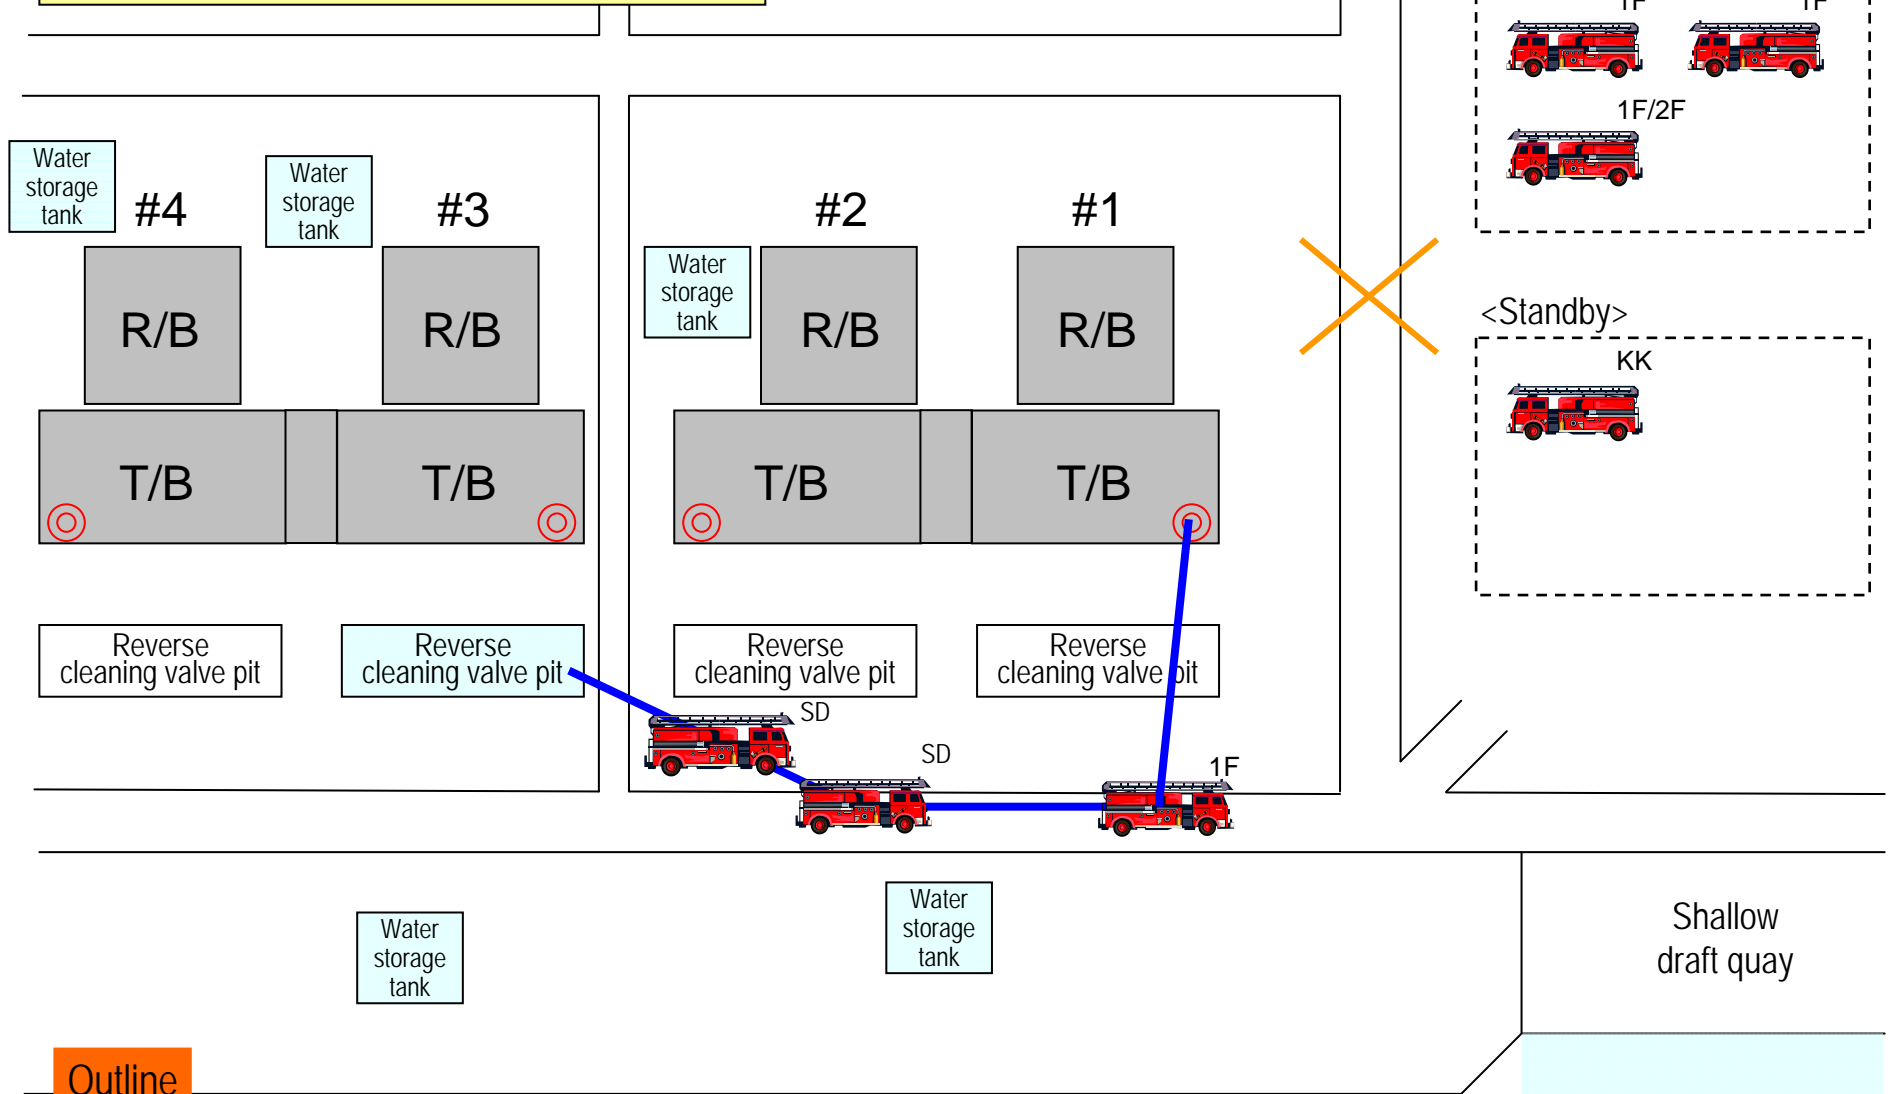
(6) Start of seawater injection to Unit 1  
(Mar 12 19:04)

- A water injection line was installed by connecting 3 fire engines in series and using the Unit 3 reverse cleaning valve pit as water source, to start seawater injection to Unit 1 at 19:04.

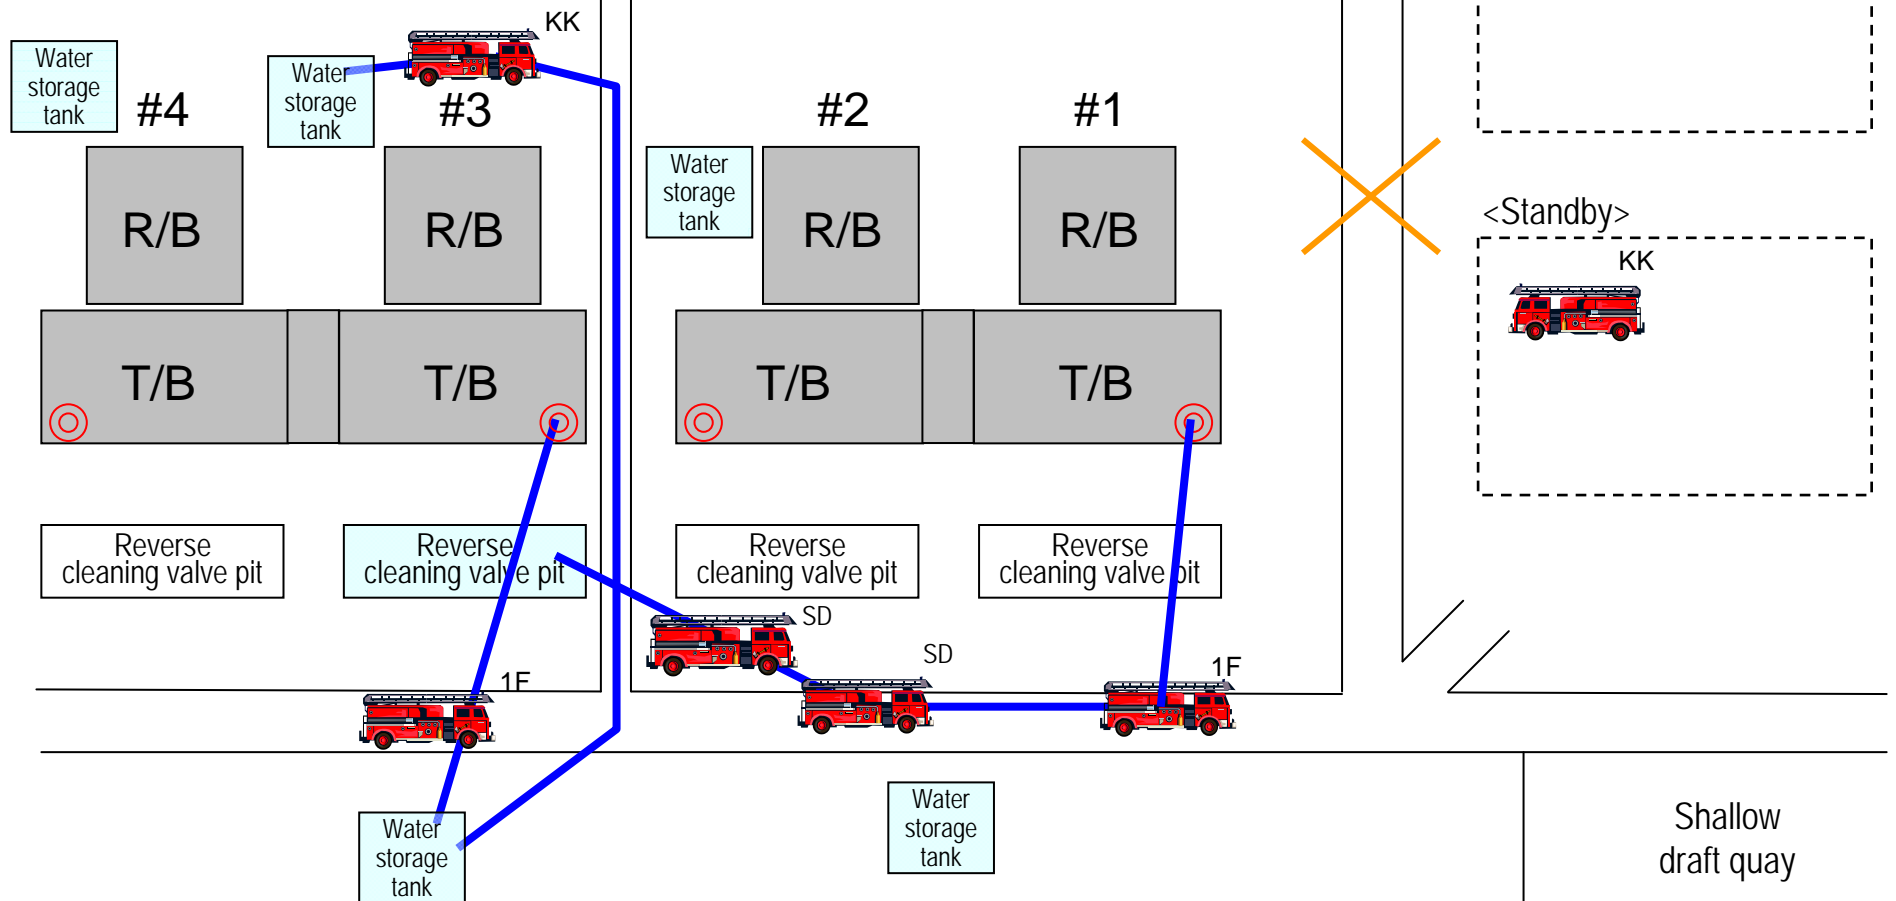
(7) Start of freshwater injection to Unit 3  
(Mar 13 9:25)

- Collected the fire engine on the Unit 5/6 side around 6:00. 1 KK standby fire engine at 2F arrived at 1F around 6:30.
- As for Unit 1, a seawater injection line was installed using seawater of the Unit 3 reverse cleaning valve pit as water source, which was later changed to freshwater injection line using water storage tanks as water source, to start water injection at 9:25.

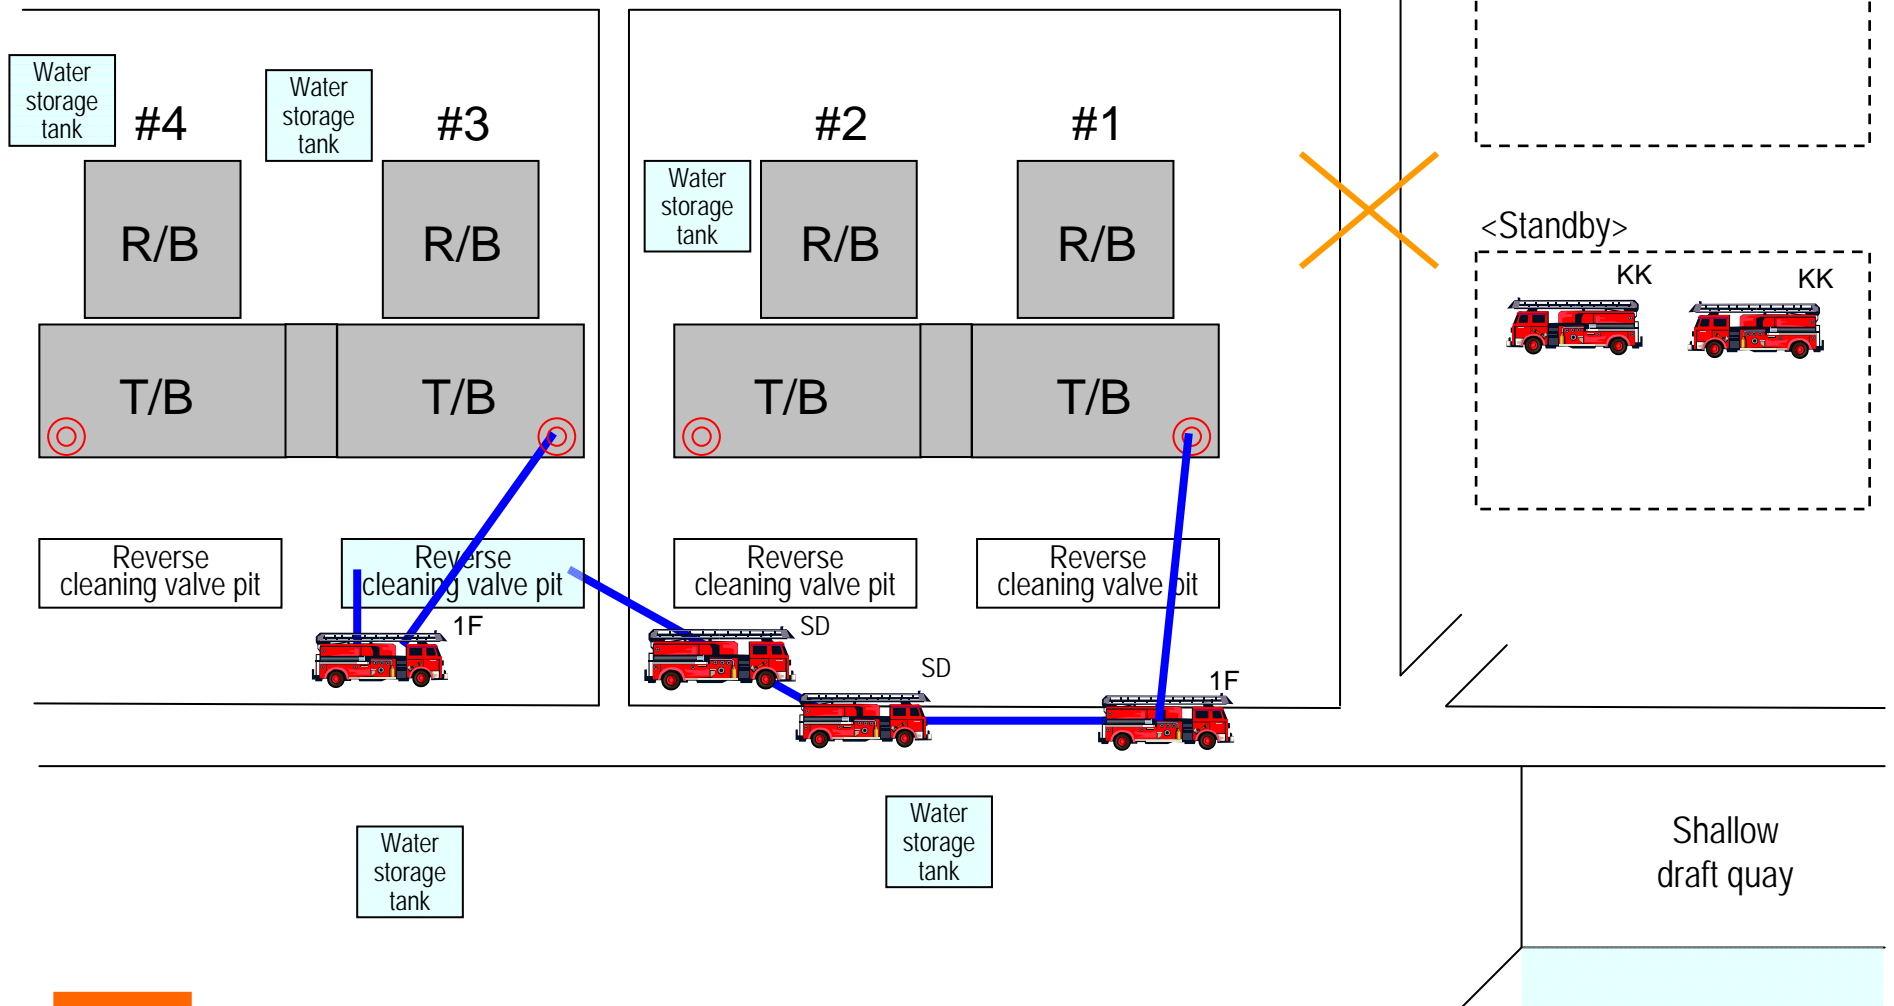
(8) Start of seawater injection to Unit 3  
(Mar 13 13:12)

- The line was changed to using the Unit 3 reverse cleaning valve pit as water source, to start seawater injection to Unit 3 at 13:12.

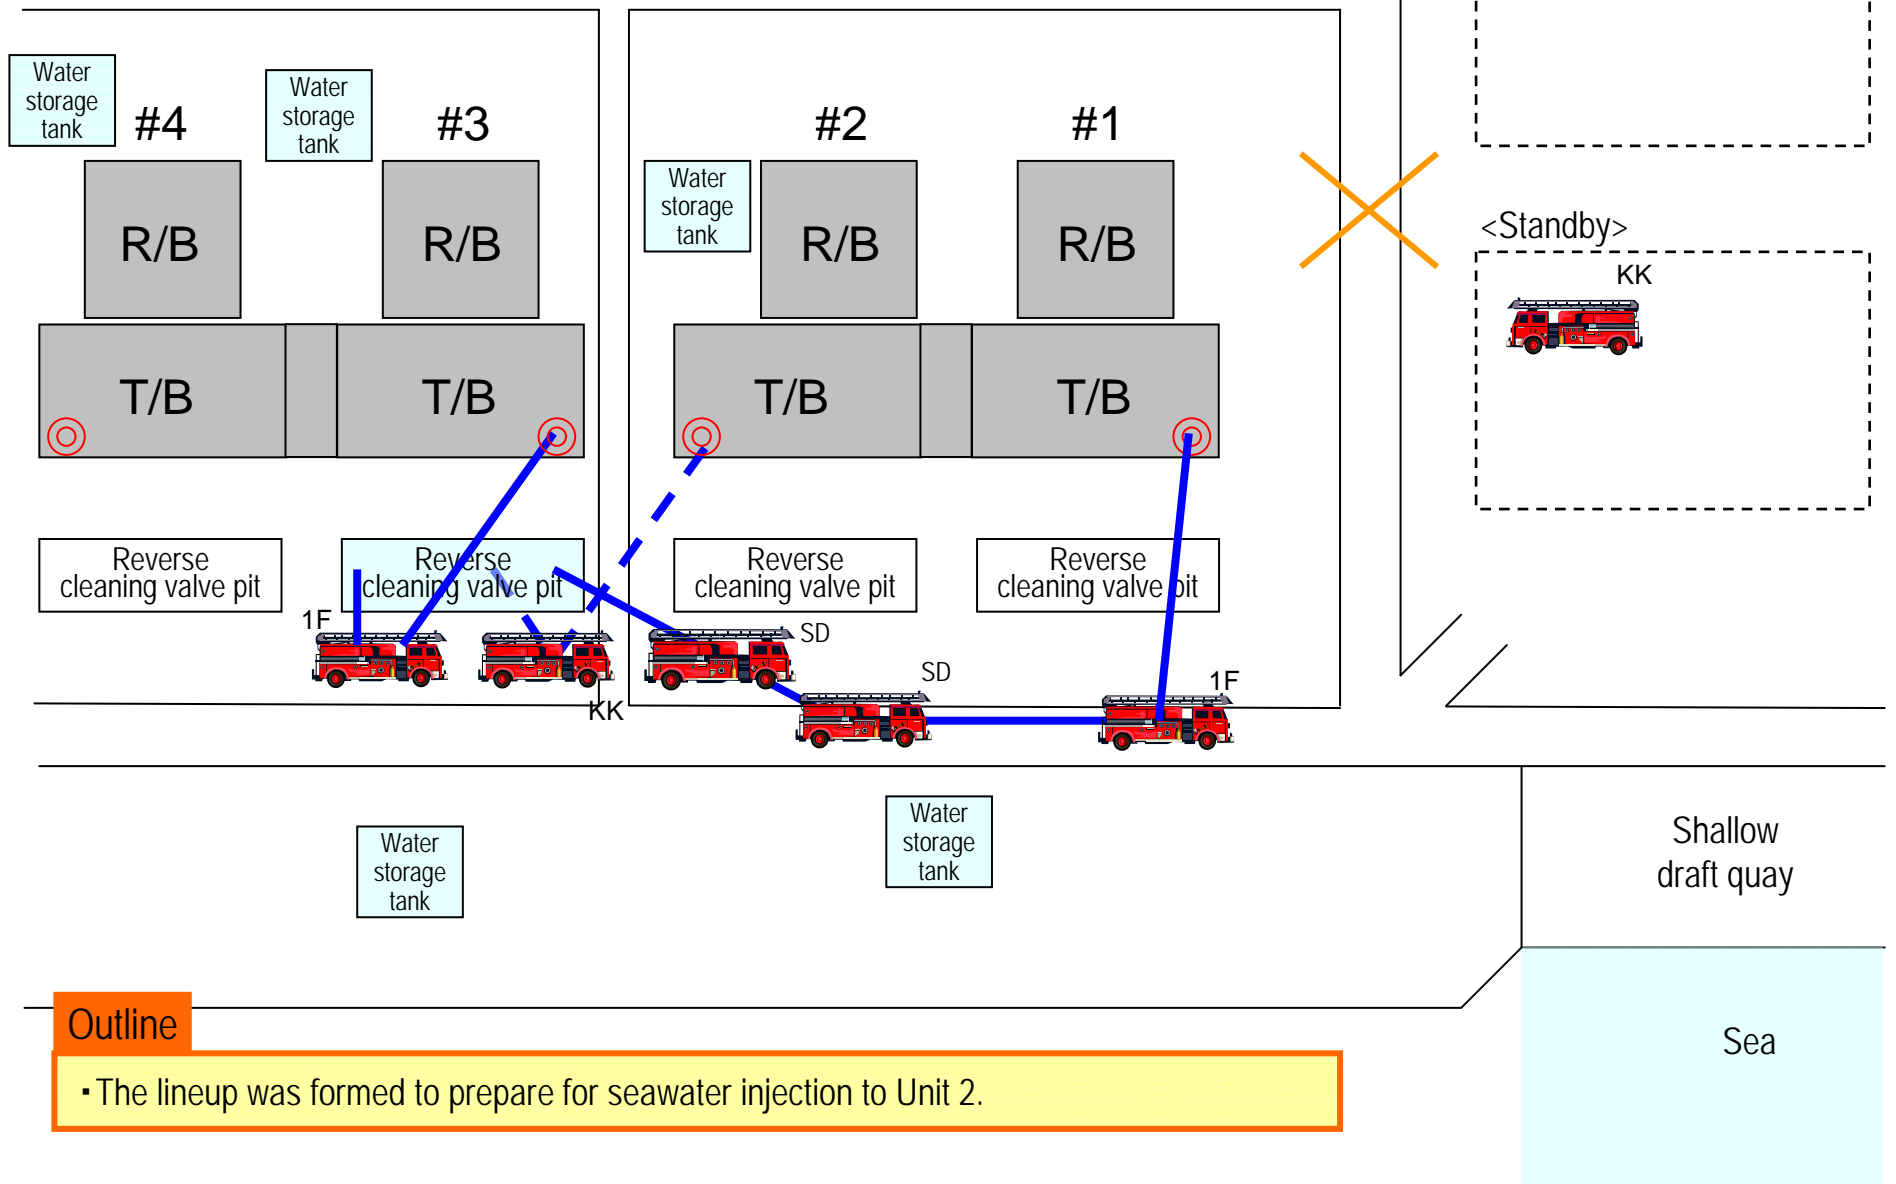
(9) Preparation of seawater injection to Unit 2  
(Mar 13 evening)

- The lineup was formed to prepare for seawater injection to Unit 2.

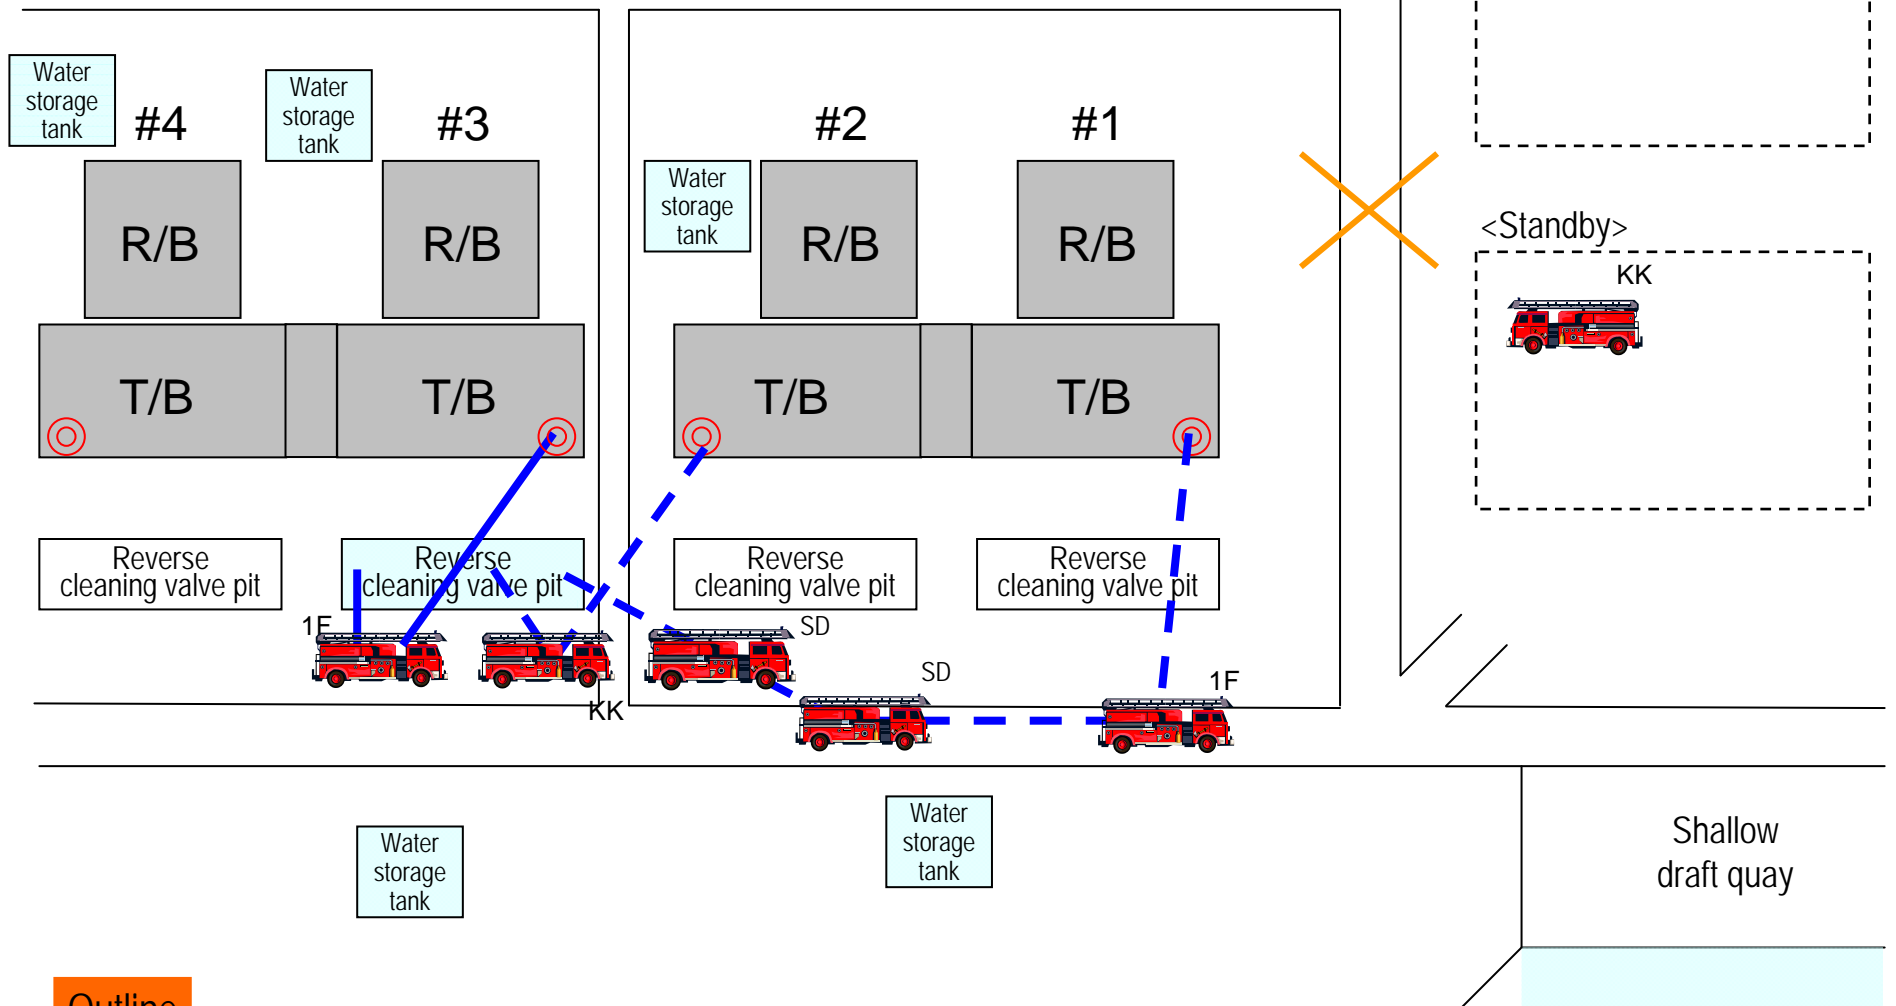
(10) Stop of fire engines / restart of water injection to Unit 3  
(Mar 14 1:10/3:20)

- At 1:10, water injection was stopped due to seawater shortage in the Unit 3 reverse cleaning valve pit.
- At 3:20, seawater became available by adjusting the pumping location of the hose, and water injection to Unit 3 was restarted.

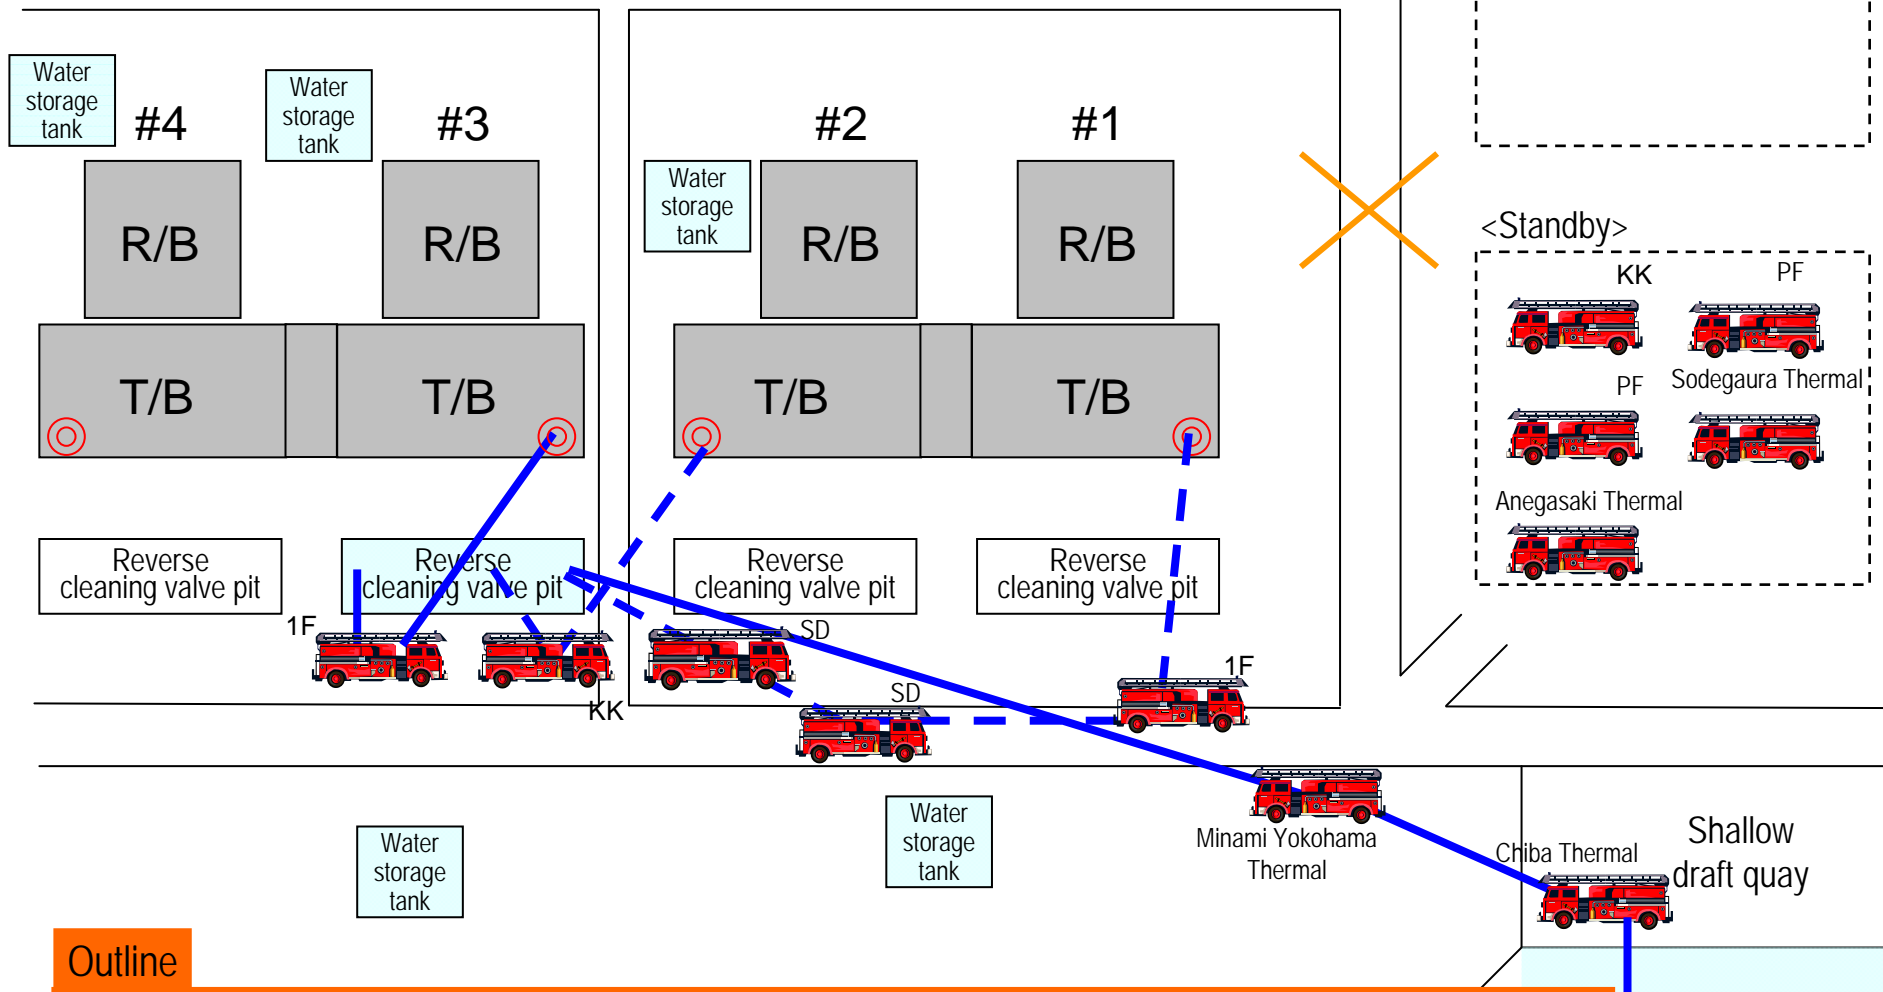
(11) Completion of water supply line from the shallow draft quay  
(Mar 14 9:05)

- On Mar 14, 2 fire engines from public fire stations arrived early morning, and at 5:03, 4 fire engines arrived from TEPCO's thermal power plants.
- Water supply line from the shallow draft quay was formed, and the fire engines were started at 9:05. Seawater was continuously supplied to the reverse cleaning valve pit.

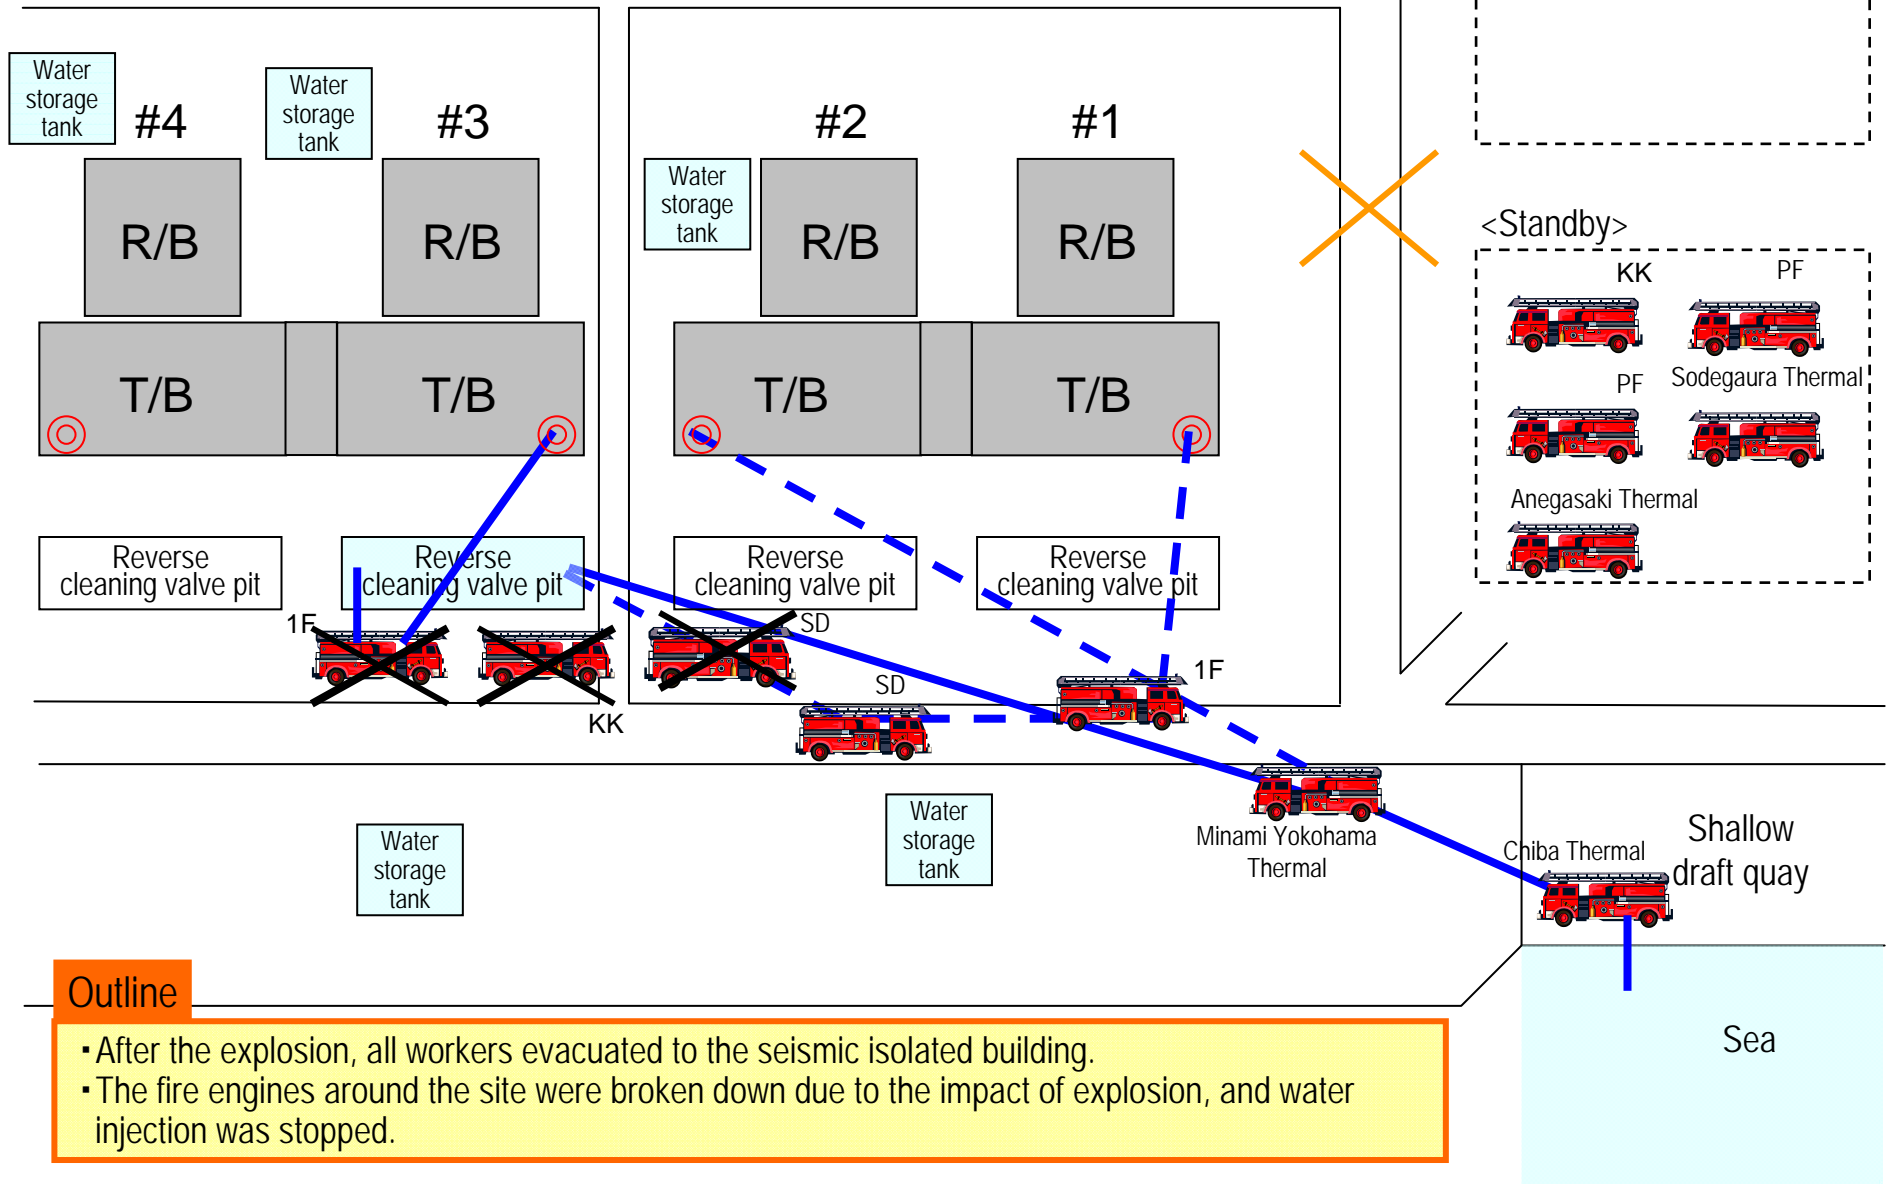
(12) Hydrogen explosion at Unit 3  
(Mar 14 11:01)

- After the explosion, all workers evacuated to the seismic isolated building.
- The fire engines around the site were broken down due to the impact of explosion, and water injection was stopped.

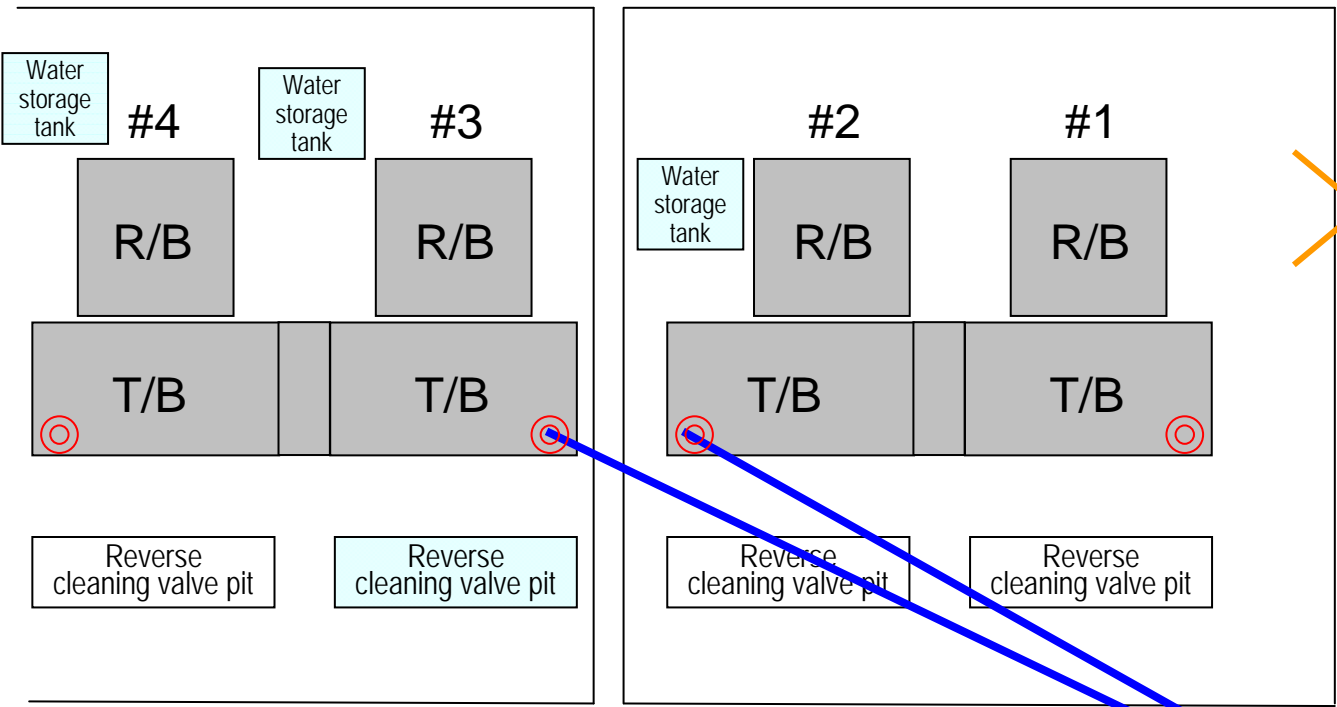
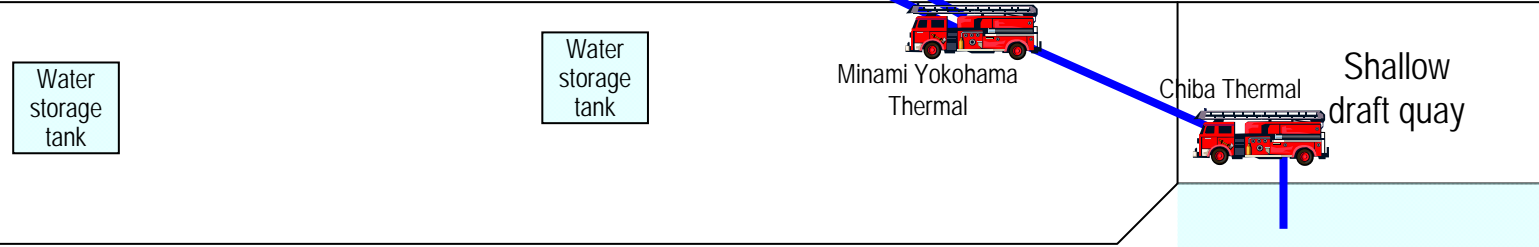
(13) Restart of water injection to Unit 3 / start of seawater injection to Unit 2  
 (Mar 14 around 15:30/19:54)

▪ A seawater injection line was installed from shallow draft quay to Units 2 and 3, and the fire engines were started around 15:30. Water injection to Unit 3 was restarted, and prepare Unit 2 to the status being injected with water after pressure decrease of the reactor. Seawater injection was started at 19:54.
