# Outline of Water Injection to Reactors by Fire Engines

Fukushima Nuclear Accident Analysis Report (Interim Report)  
which was released on Dec. 2, 2011

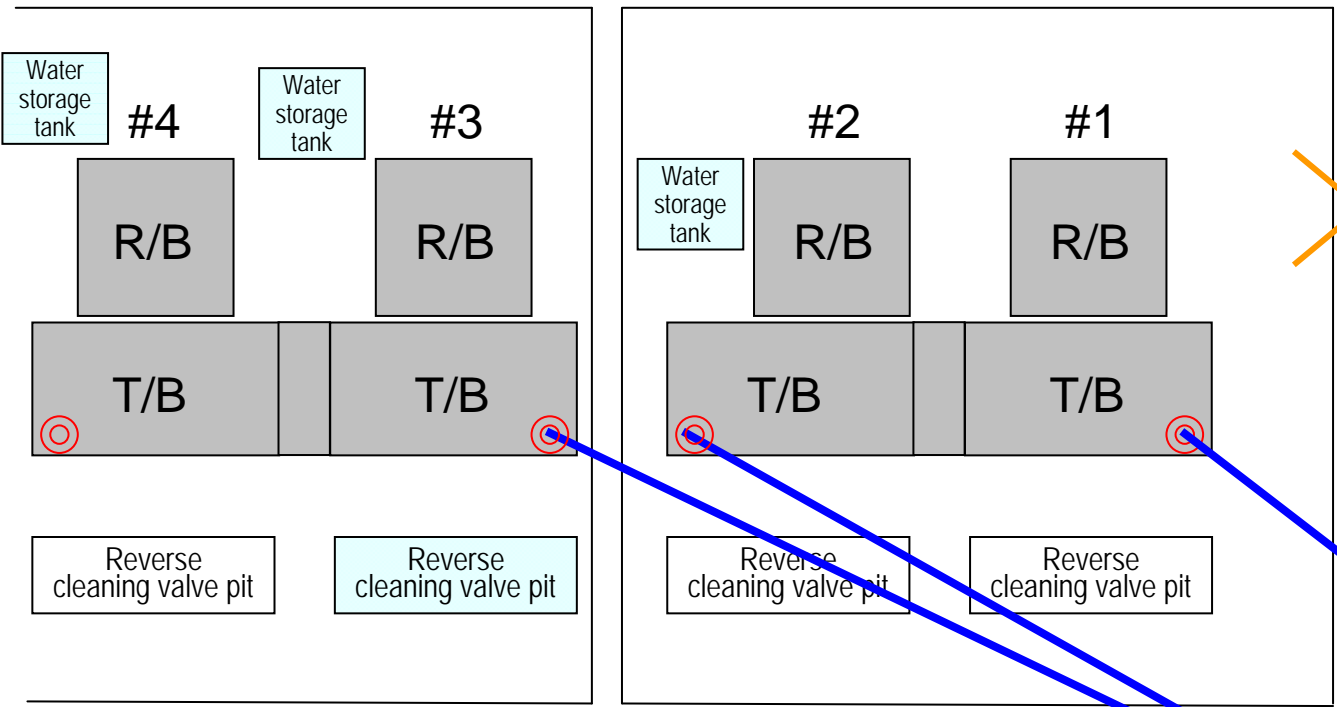
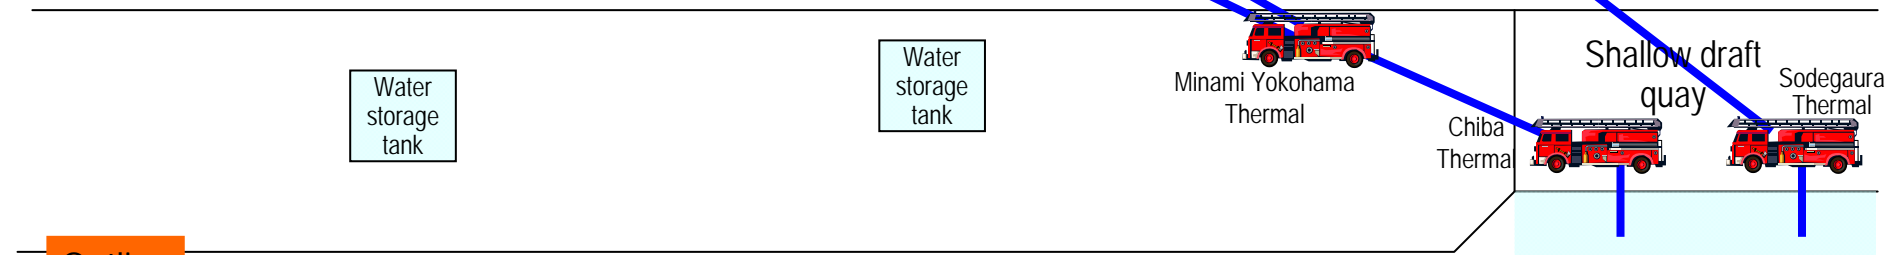
(14) Restart of water injection to Unit 1  
(Mar 14 around 20:00)

- Around 20:00, restart of water injection to Unit 1 was confirmed.
