# Outline of Water Injection to Reactors by Fire Engines

Fukushima Nuclear Accident Analysis Report (Interim Report)  
which was released on Dec. 2, 2011

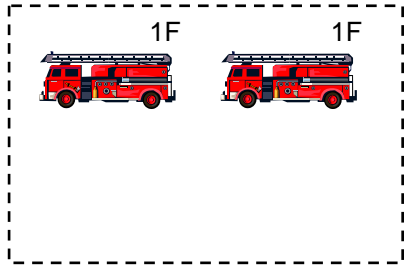
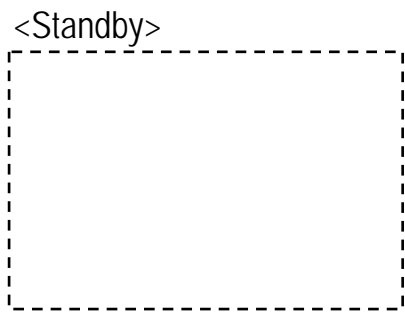
(3) Restart of freshwater injection to Unit 1  
(Mar 12 around 5:46)

- Self-Defense Forces and partner companies went to the site by fire engine and restarted the water injection at 5:46.

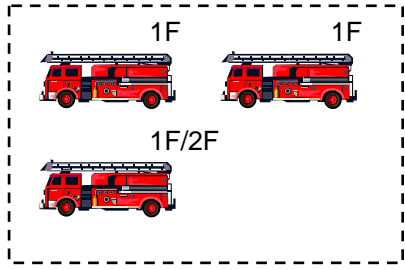
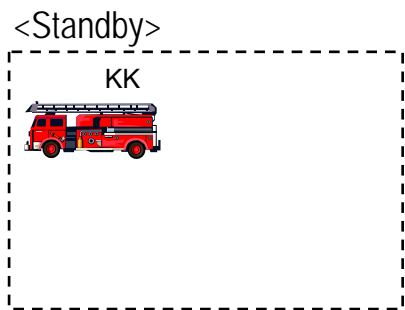
(5) Hydrogen explosion at Unit 1  
(Mar 12 15:36)

- After the explosion, all workers evacuated to the seismic isolated building.
- The hose prepared for seawater injection was damaged and not usable due to the impact of explosion.

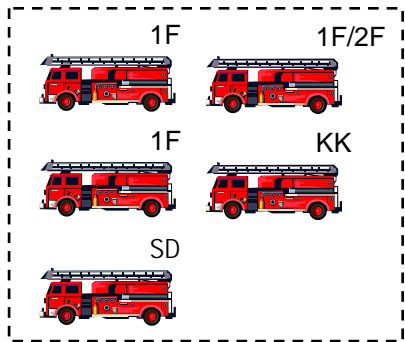
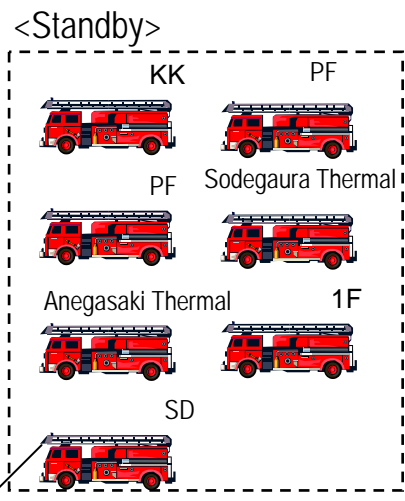
(13) Restart of water injection to Unit 3 / start of seawater injection to Unit 2  
 (Mar 14 around 15:30/19:54)

▪ A seawater injection line was installed from shallow draft quay to Units 2 and 3, and the fire engines were started around 15:30. Water injection to Unit 3 was restarted, and prepare Unit 2 to the status being injected with water after pressure decrease of the reactor. Seawater injection was started at 19:54.

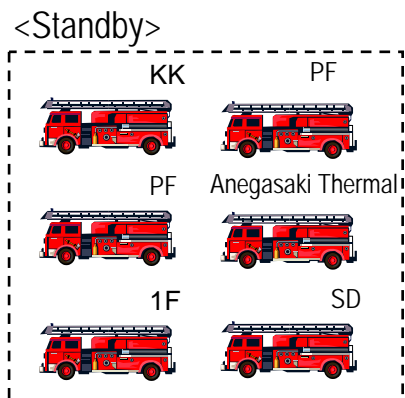
(14) Restart of water injection to Unit 1  
(Mar 14 around 20:00)

- Around 20:00, restart of water injection to Unit 1 was confirmed.
